## Engineer's Opinion

On 8/21/2026 a truss evaluation was performed at the property located at address [REDACTED] Cibolo, TX, 78108, which consists of a 1681 square-foot single family attached structure built in 2015 (11 years old) with a slab on grade foundation.

*Site Assessment for:*  
**Damaged Truss Evaluation Inspection**

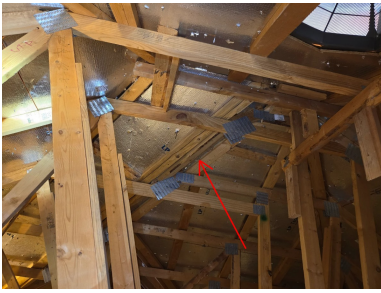
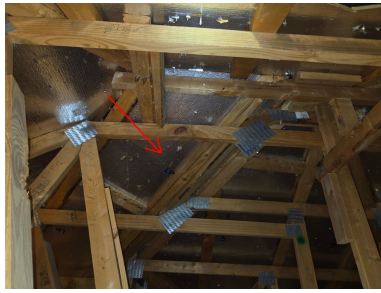
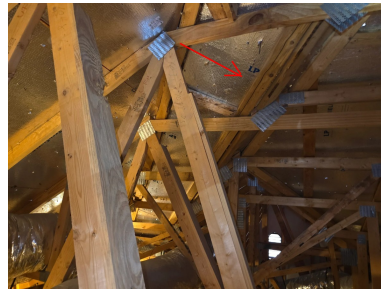
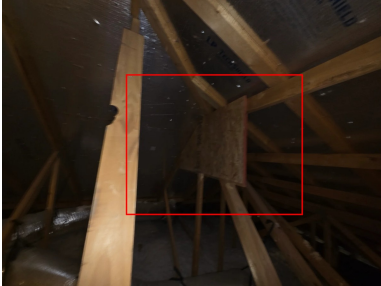
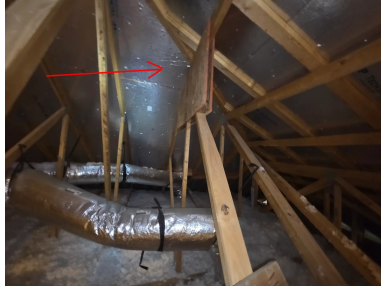
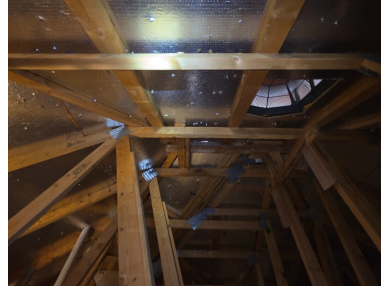
Modifications to portions of the roof truss framing were noted where members appear to have been altered to provide clearance for the HVAC equipment and associated installation. The documented modifications appear localized in nature, and certain repairs or supplemental framing measures appear to have been installed to restore the intended support and performance of the affected truss members. No significant displacement, loss of support, or other visible indication of substantial structural distress was observed at the modified areas.

Modified truss

Modified Truss

Based on the documented conditions, the observed truss modifications appear localized and certain supplemental framing measures appear to restore the intended support and performance of the affected members. The minor cracking or checking observed within various roof and truss framing members is consistent with normal wood shrinkage, seasoning, and dimensional changes associated with attic temperature and moisture fluctuations, and no significant structural distress was documented. These areas should be monitored as part of routine roof and attic maintenance for any widening, displacement, separation, or increase in the number of affected members. Based on the conditions presently documented, no structural corrective action is considered necessary at this time.

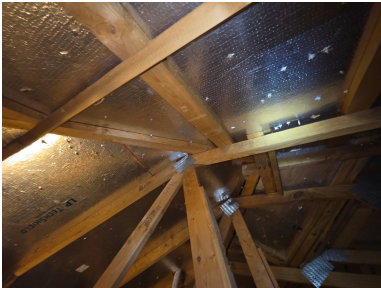
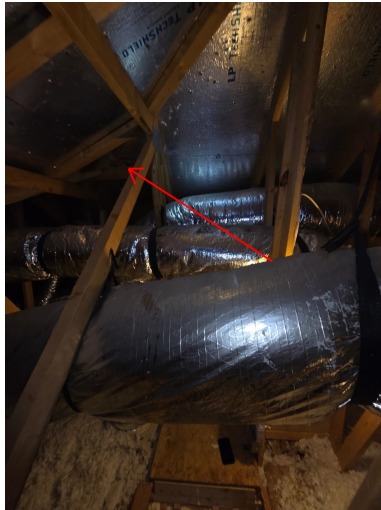
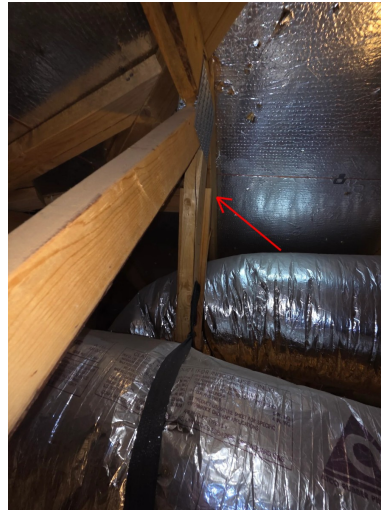
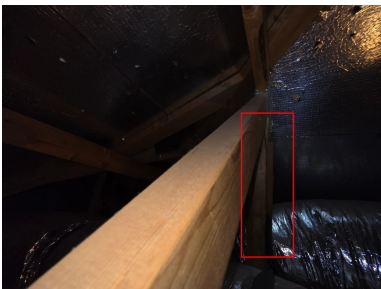
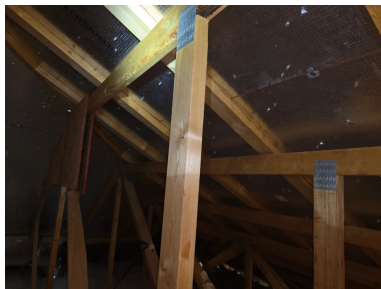
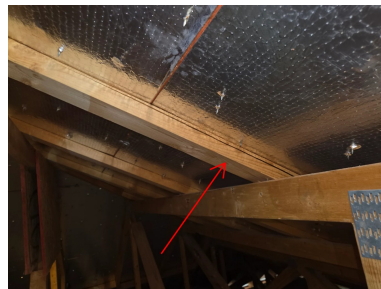
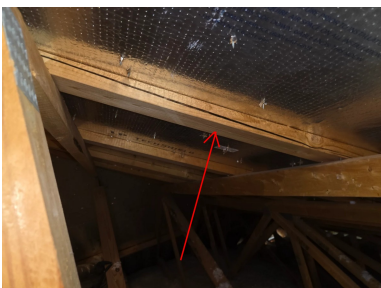
Minor cracking or checking was observed at various locations within the roof and truss framing members. These conditions are commonly associated with normal wood shrinkage, seasoning, and dimensional changes resulting from fluctuations in attic temperature and moisture conditions over time. Although this type of cracking is not ideal, isolated occurrences generally do not represent a significant structural concern unless they become widespread, are accompanied by displacement or separation, or affect a substantial number of framing members. Wood roof framing and truss systems are also designed with inherent safety factors that provide reserve capacity beyond normal service loads.

**Multiple roof truss framing members were observed to be damaged/split.**

Multiple roof truss framing members were observed with damage/splitting. The affected members were not concentrated in one specific area but were observed at various locations throughout the attic. No excessive movement or conditions that appeared immediately unsafe were observed when accessible framing members were checked using light manual pressure.

Multiple roof truss members were observed with significant longitudinal splitting/cracking extending along substantial portions of the members. The affected trusses require repair.
