PROPERTY INSPECTION REPORT FORM

June 15, 2026

1112 Cupertino Portland TX 78374

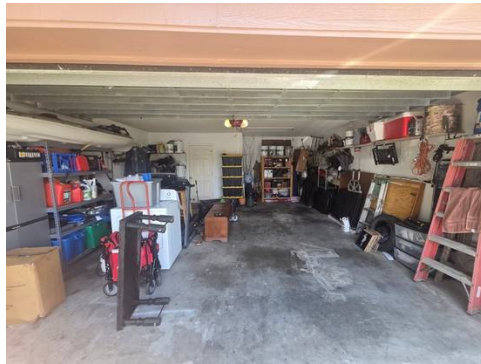
Visual inspection of the interior garage walls was obstructed by personal storage and stored items. Consequently, a complete evaluation of the wall surfaces could not be performed.

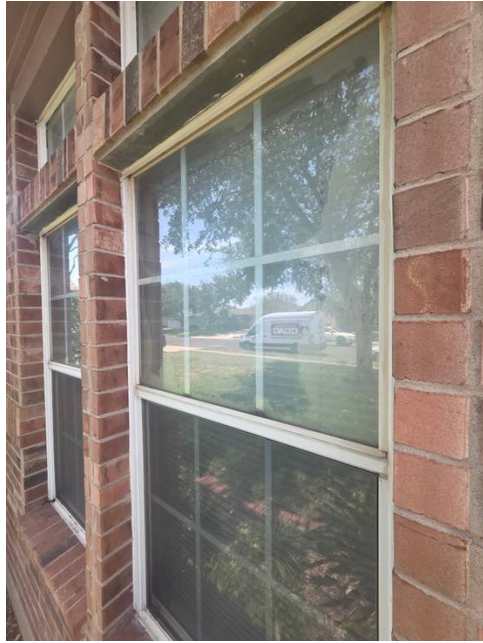
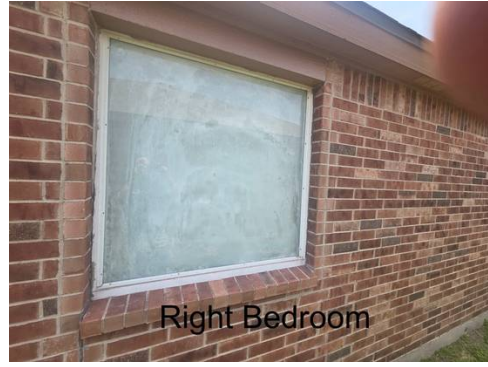
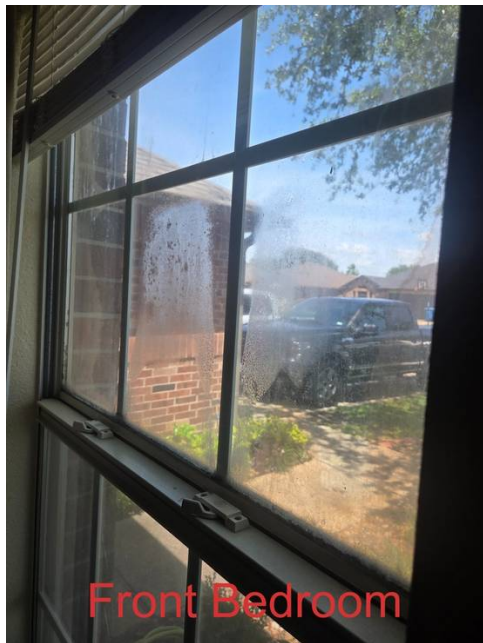
One or more insulated glass windows showed failed seals with fogging/moisture between panes. This affects visibility and efficiency. Recommend repair or replacement by a qualified professional.

One or more insulated glass window units exhibited failed seals with visible fogging/moisture between panes.

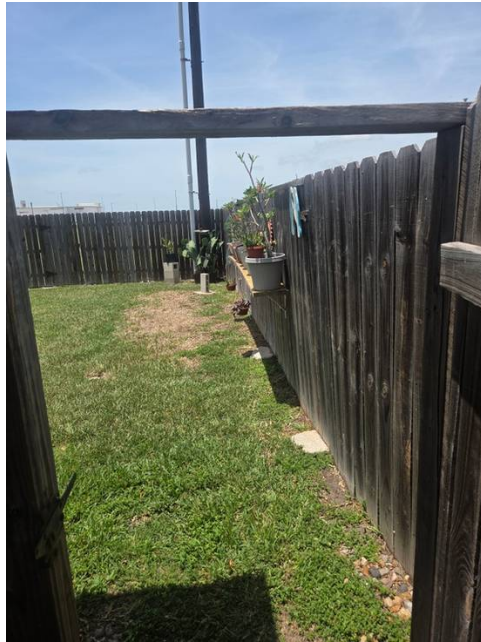
A low horizontal beam was installed across the fence entrance, creating a potential head-strike hazard. Recommend modification or removal to improve safe access.

Low horizontal beam at fence entrance presents a potential head-strike hazard.

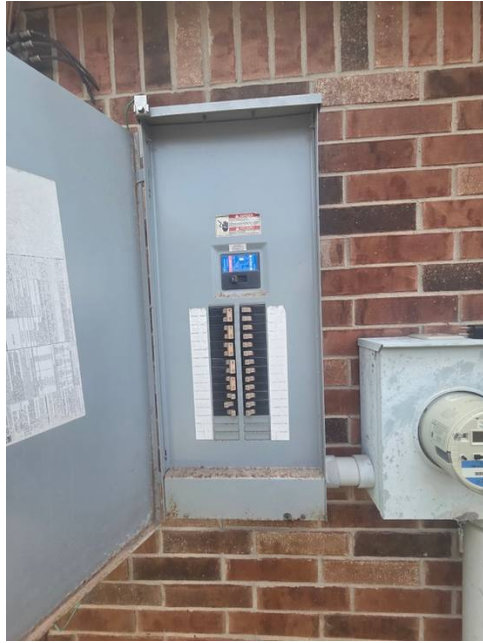
Rust was observed on the electrical panel cover, indicating possible moisture exposure. Moisture may affect internal components. Recommend evaluation by a licensed electrician.

Rust observed on the electrical panel's dead front cover. This typically indicates past or ongoing moisture exposure at the panel location. Moisture can lead to corrosion of internal electrical components and may affect panel performance or safety.

Rust observed on electrical panel cover indicating possible moisture exposure.

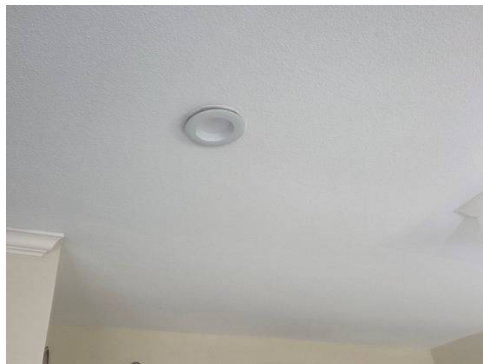
Near kitchen entrance.

A recessed light fixture was loose and not fully secured to the ceiling surface. Recommend repair or adjustment by a qualified person.

Recessed light fixture near kitchen entrance was loose and not fully secured.

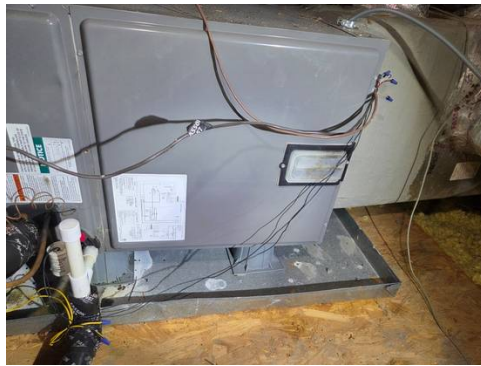
The air handler was visually inspected. The service cover could not be safely removed because wiring restricted access. Inspection was limited to visible and accessible components

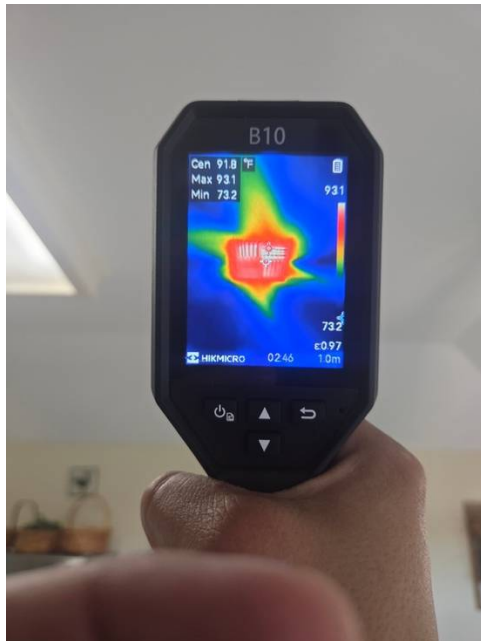
Return heat @ 91.8

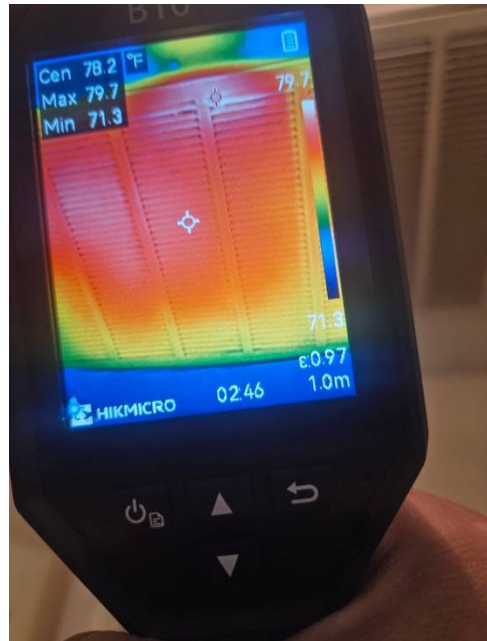
Supply temp @ 78.2

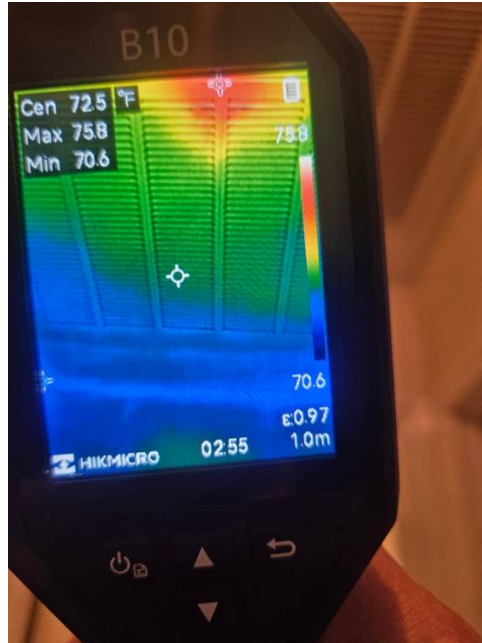
Supply @ 72.5

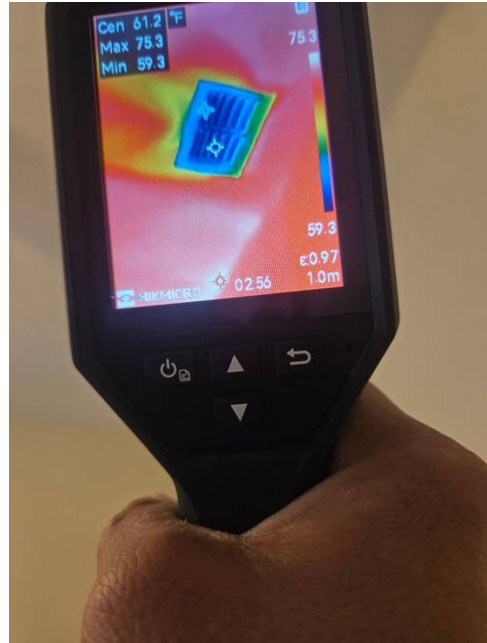
Return cooling@ 59.3

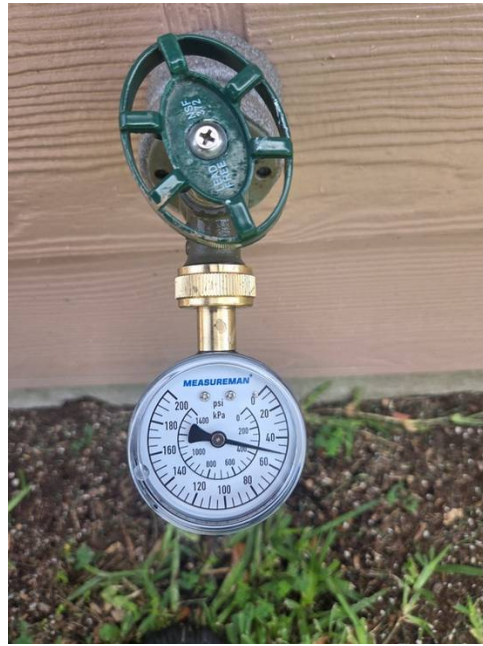
45 psi

Static water pressure measured within the standard acceptable range of 40–80 PSI at the exterior hose bib.

Water pressure was adequate at time of inspection.

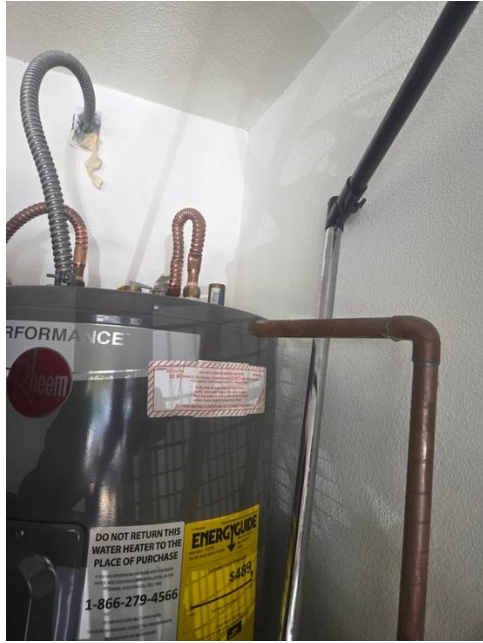
The water heater TPR valve was missing its discharge pipe. This is a safety hazard. Recommend installation of a proper discharge pipe by a qualified plumbing contractor.

Water heater TPR valve discharge pipe missing.

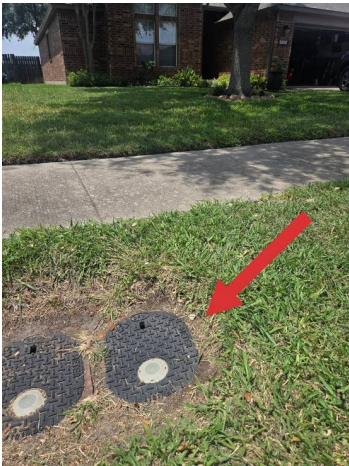
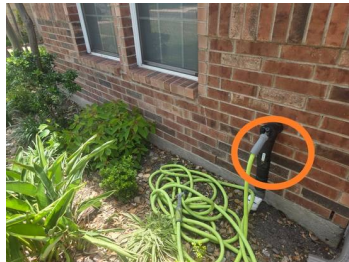
Water meter and main shutoff location for client reference. No deficiencies observed.

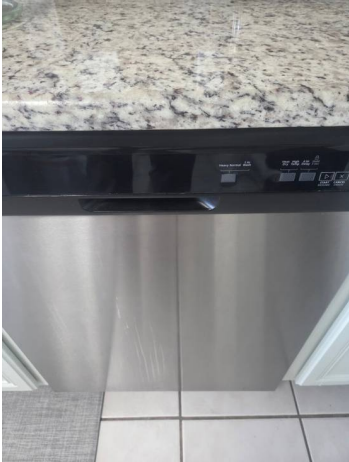
The dishwasher was not inspected. The unit did not have power at the time of the inspection, and its operation could not be verified.

Dishwasher not tested due to lack of power at time of inspection.

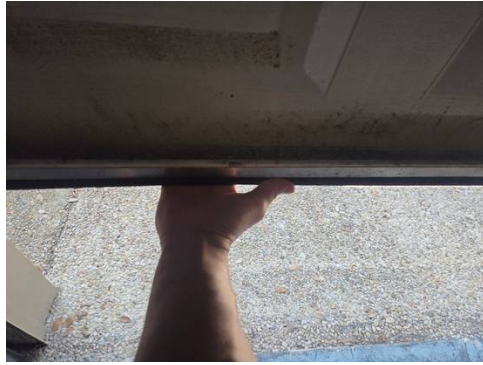
Garage door opener reversed direction properly when resistance was applied during testing.

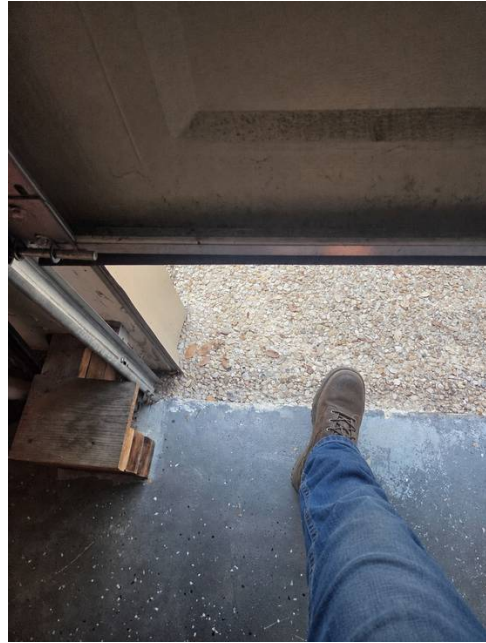
Photoelectric safety sensors operated properly at time of inspection.
