Report V1.0

# Engineer's Foundation Evaluation

123 Main St, Your City, TX, 12345

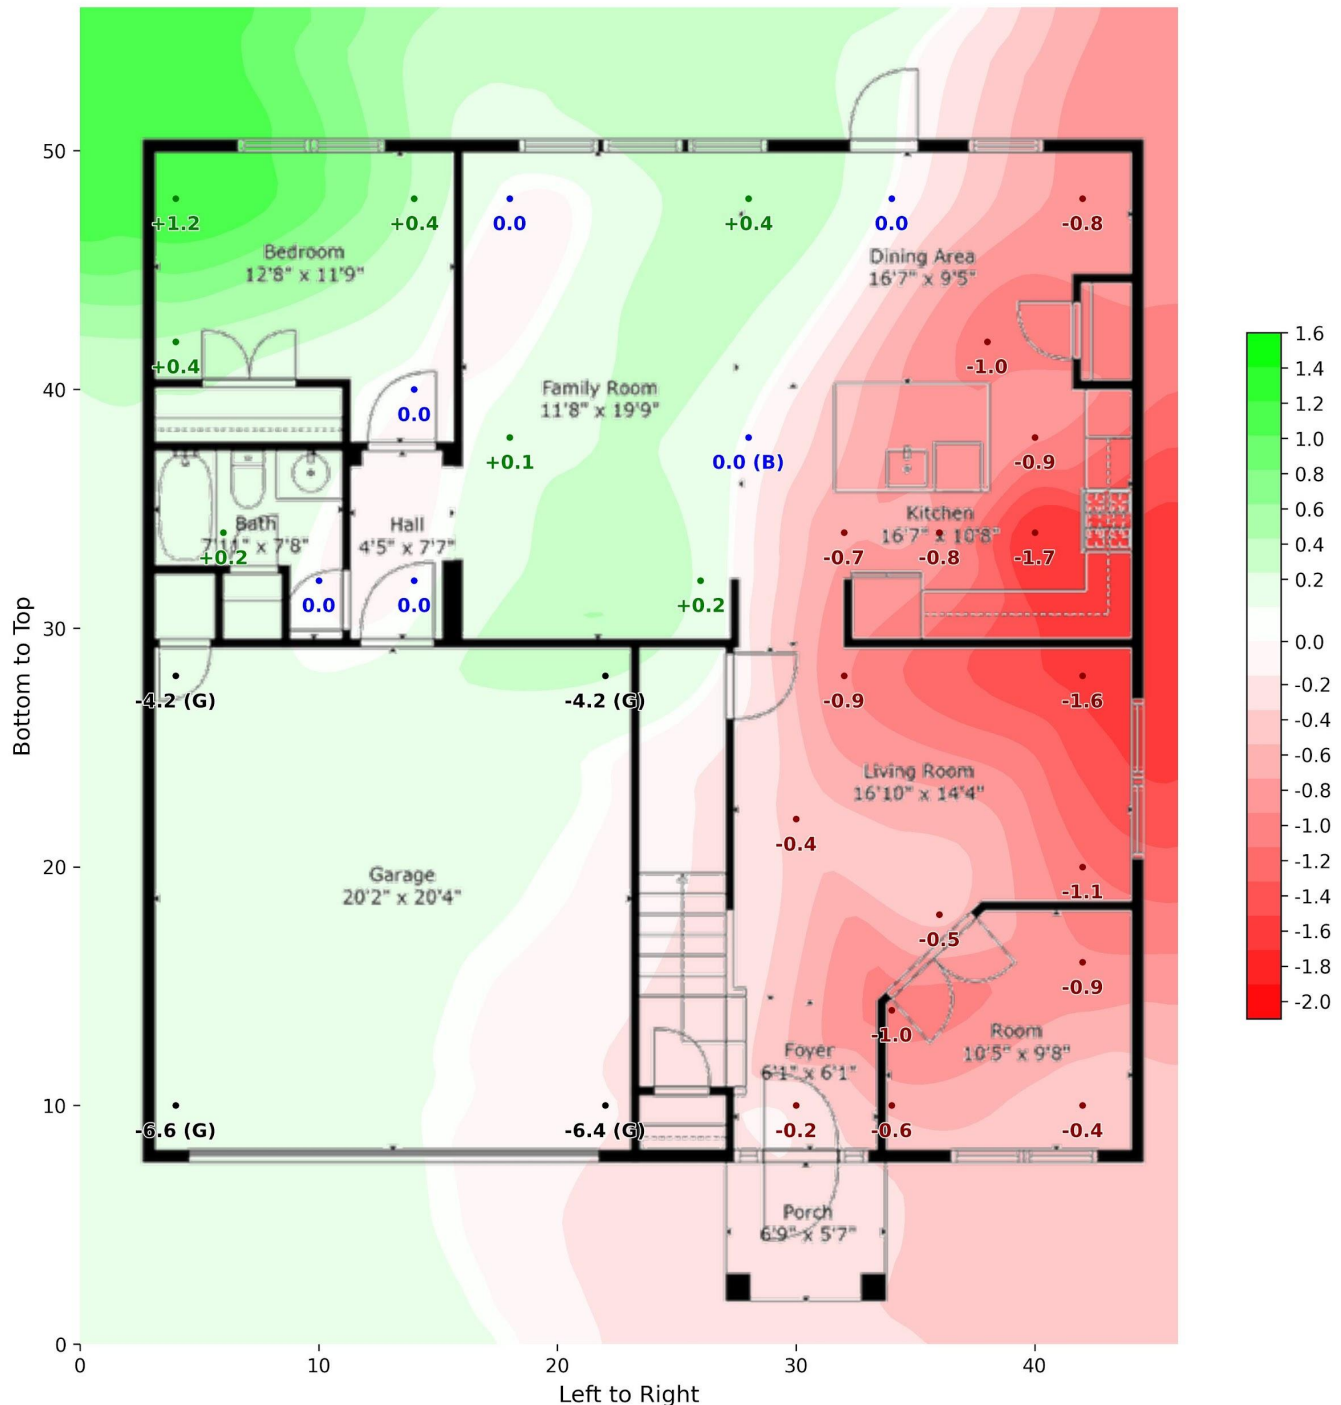
Elevation Plot Graphic (Figure A)

The elevation plot resulted in the graphic as depicted above in Figure A. The red-points and areas are elevation measurements that were lower than the base station elevation (0.0). The green-points and areas are elevation measurements that were higher than the base station elevation (0.0). The blue-points (and white areas) are equal to the base station elevation (0.0). The base station is depicted with a (B) symbol. The elevation plot takes into account differences in flooring thicknesses. The maximum elevation point was determined to be 1.2 inches and the minimum was -1.7 inches, resulting in an elevation difference of 2.9 inches of difference across the structure.

The elevation plot graphic above will show points labeled with a (G) symbol representing Garage. These elevation points were measured and plotted so they can be compared year-to-year, however, they are excluded from the foundation analysis. This is because garages can be non-monolithic and/or they are poured to purposefully slope toward the exterior garage door making any conclusions derived difficult to interpret.

Elevation differences across the structure are the first indicator that a foundation problem may or may-not exist. As documented above, the maximum elevation point of this structure was determined to be 1.2 inches and the minimum was -1.7 inches, resulting in an elevation difference of 2.9 inches of difference across the structure. The elevation plot takes into account differences in flooring thicknesses. The elevation deflection across an entire structure should, best-case-scenario, remain within 0.5 to 1-inch depending on the age of the structure. Measured differences approaching 2-inches are an initial sign of possible foundation fatigue. The maximum allowable elevation difference is subjective, depending on other factors such as the visual condition, size, and age of the structure (18 year(s) old) along with how the foundation performs when calculating deflection and tilt.

Based on observed elevations of the foundation from the elevation plot, the elevation differences do not fall within industry standards and tolerable limits. These findings indicate that the foundation does not have consistent and uniform elevation measurements. Note: elevation measurements alone are not the only indicator of foundation problems; see the deflection and tilt calculations (and the report's overall conclusion) for a complete understanding of foundation stabilization. If elevations fall outside of industry standard/tolerable limits, it is a first indicator that the foundation will fail in deflection and/or tilt.

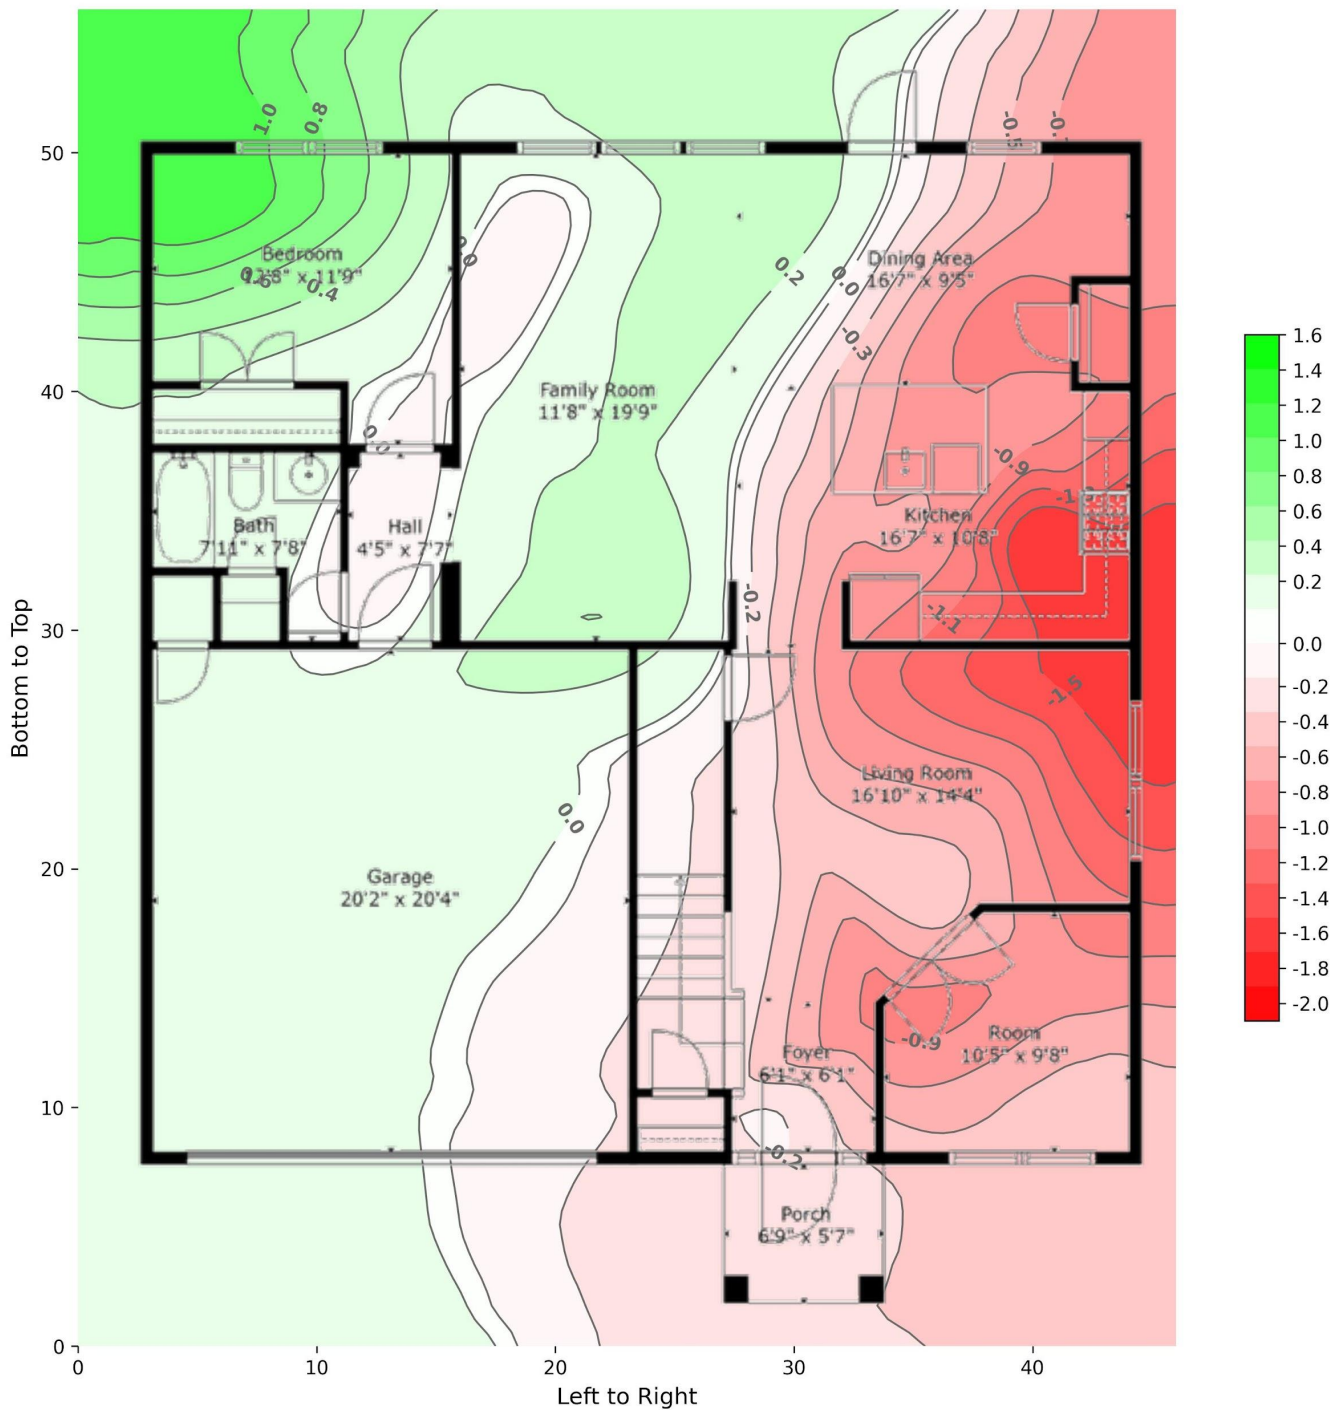
**Mesh Contour Graphic (Figure B)**

The mesh contours graphic depicted above in Figure B is similar to the elevation plot. The red, green, and white areas depict areas that are lower, higher, and equal to the base station elevation (0.0). The lines or contours (similar to map topography) are labeled at specific intervals.

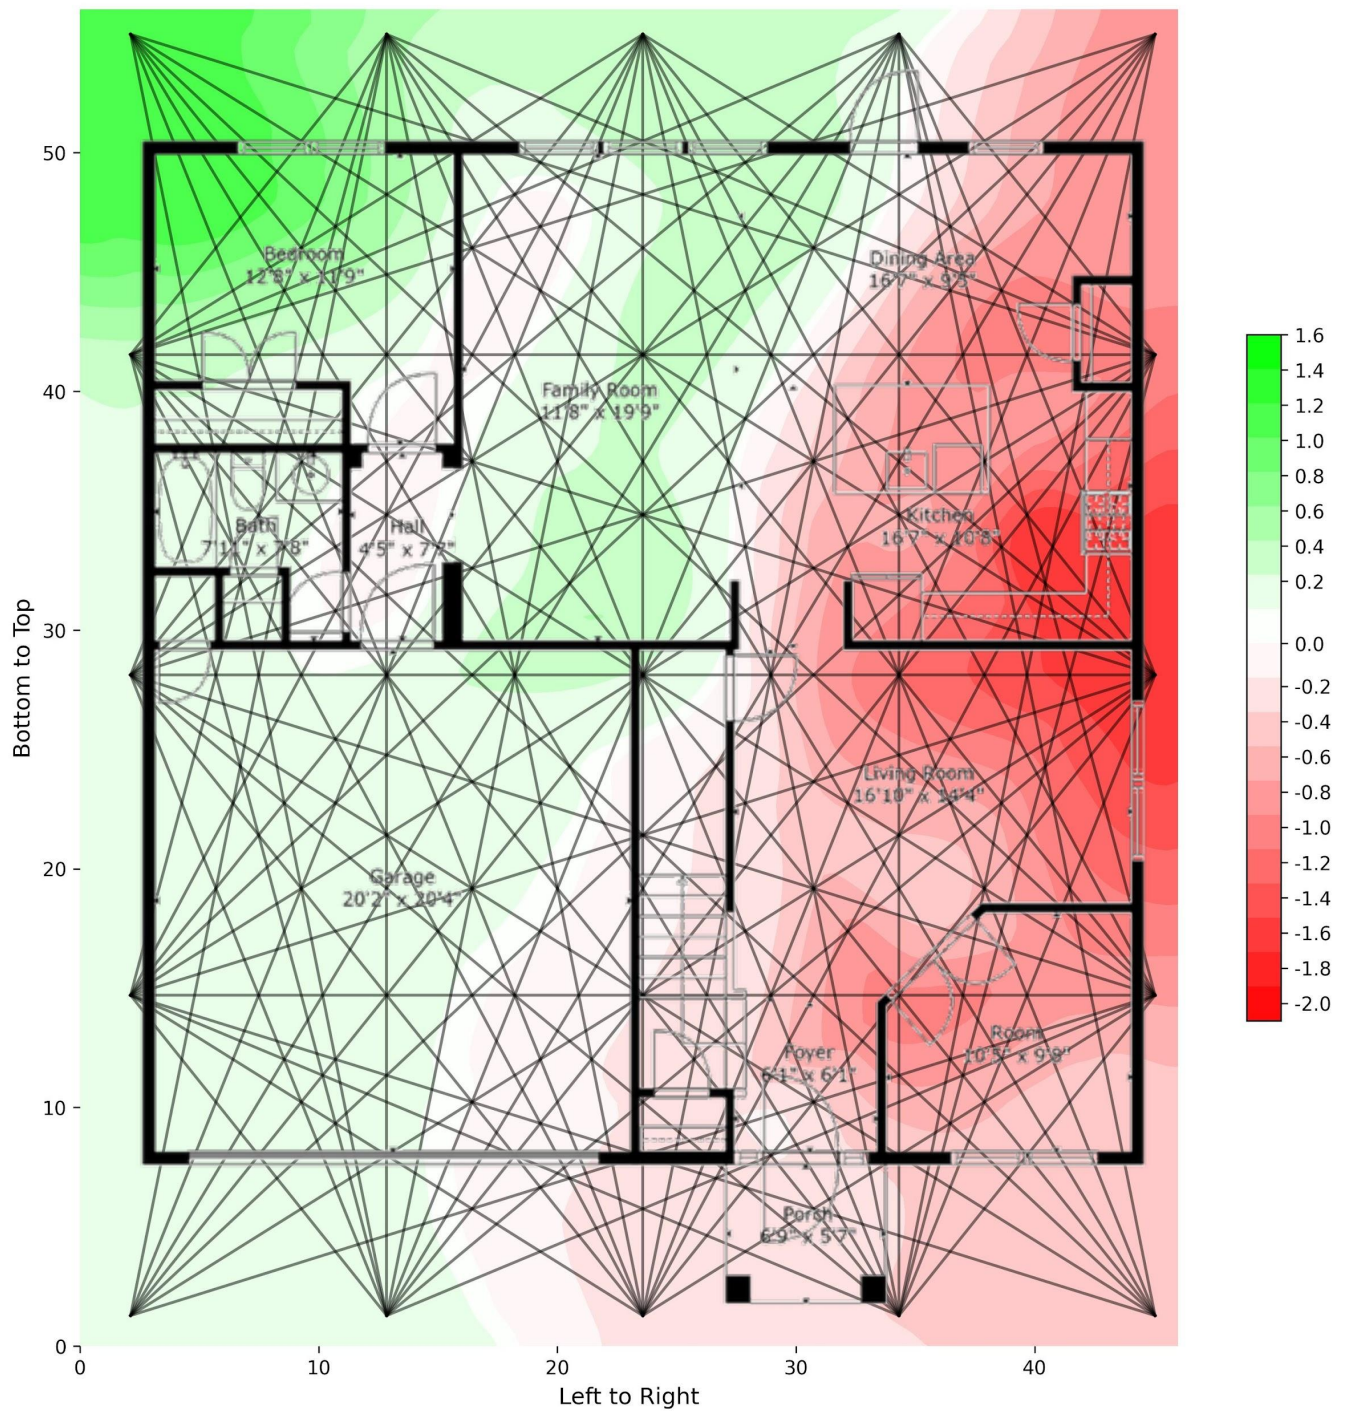
**All Profiles Graphic (Figure C)**

Below is a graphic that shows the locations of deflection and tilt profiles that were calculated. The total profiles calculated was 79 with a total usable profiles (above the effective length threshold) of 75.

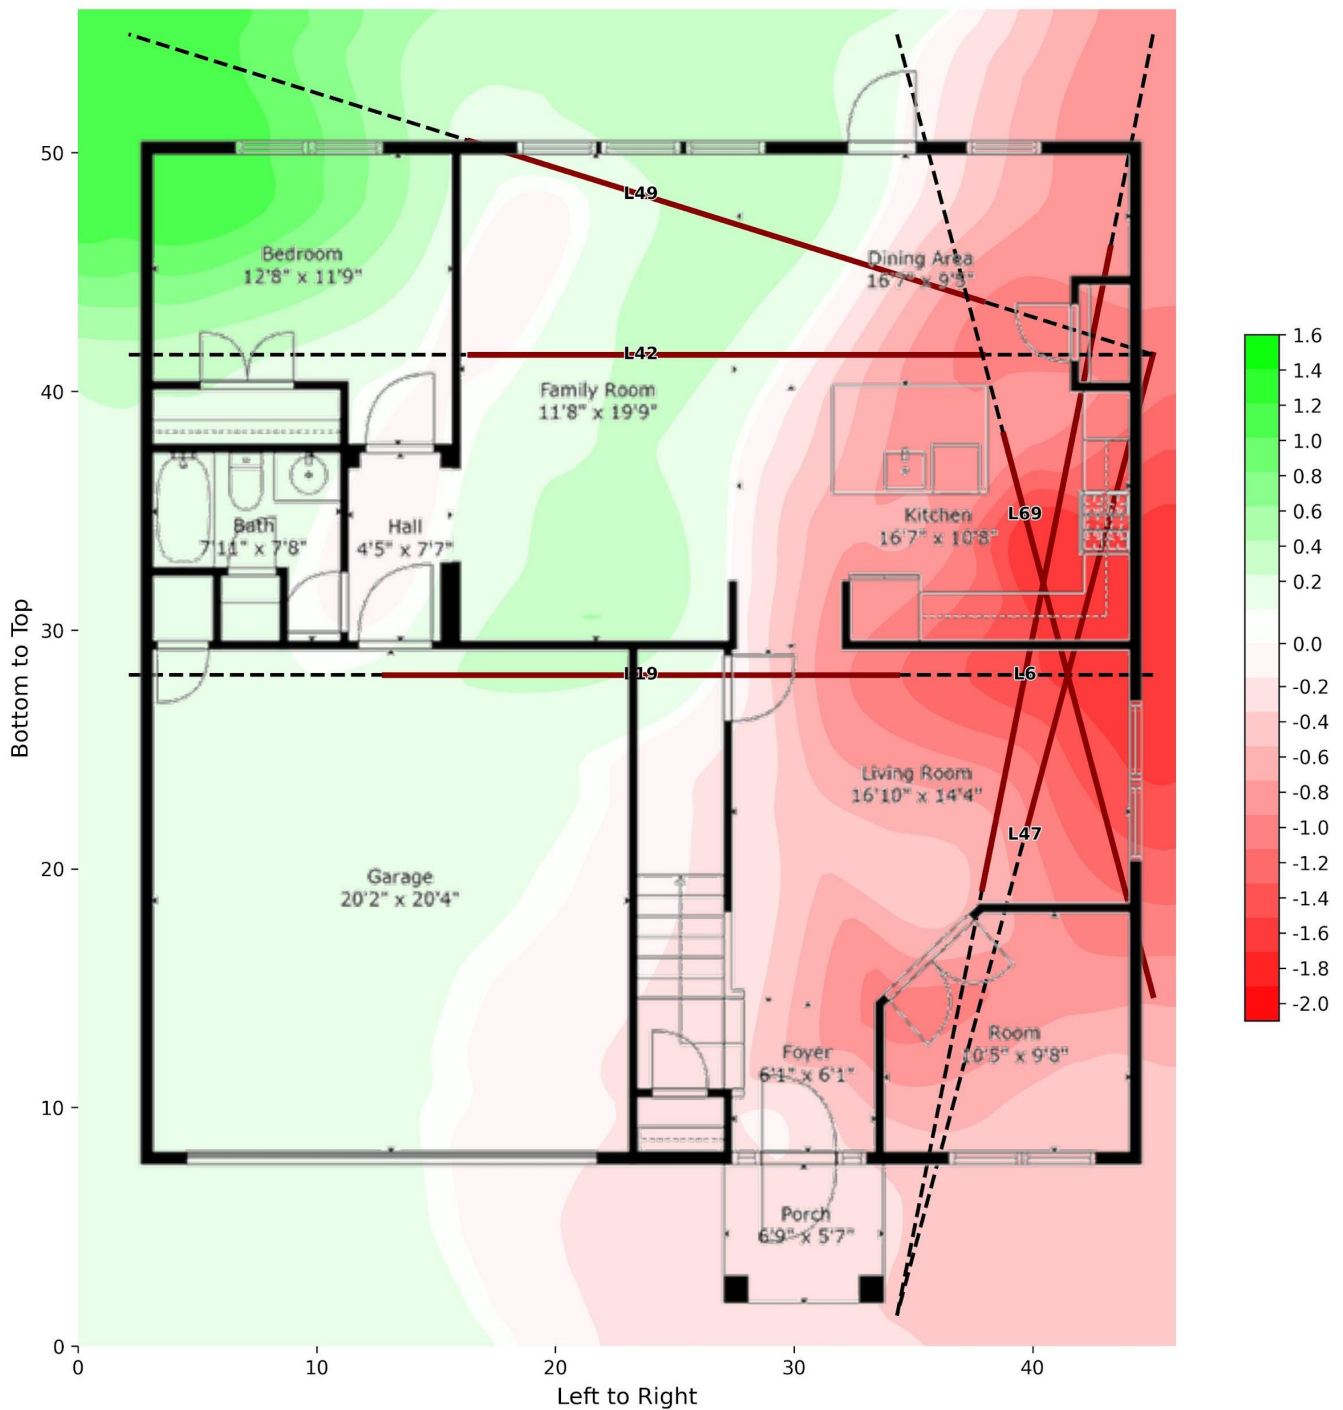
Below is a graphic that indicates the locations of the 6 deflection calculation failures.

The above Figure D shows deflection failures along the foundation. Deflection failures can be considered localized failures in (sometimes) isolated portions of the foundation. The profile lines that were calculated are represented by a dashed black line and the areas where the deflection failures occur are represented by a dark red line segment. Of the 75 deflection profiles calculated, 6 profile failures were identified.

Deflection failures can be considered localized failures of the foundation in (sometimes) isolated portions of the foundation. Of the 75 deflection profiles calculated, 6 failures were identified.

Deflection failures are above standard acceptable limits; they exceed industry-standard thresholds and the structure should be considered actively moving/settling in areas where deflection failures are occurring. See the report's overall conclusion for a complete understanding of the overall foundation stabilization issue.

**To stabilize and lift the foundation, install and/or adjust perimeter and interior piles/piers as shown in the attached Exhibit A - Proposed Repair Plan. The underpinning may be concrete cylinders, steel pipe, helical screws, or drilled concrete piers – refer to Exhibits D, E, F, and G. Underpinning will not improve the performance of the foundation in non-underpinned areas. Note, any foundation movement, even corrective, can cause additional cosmetic distress. The contractor shall determine the amount of elevation correction needed based on the reaction of the structure during the adjustment in order to minimize stress and additional cosmetic damages.**

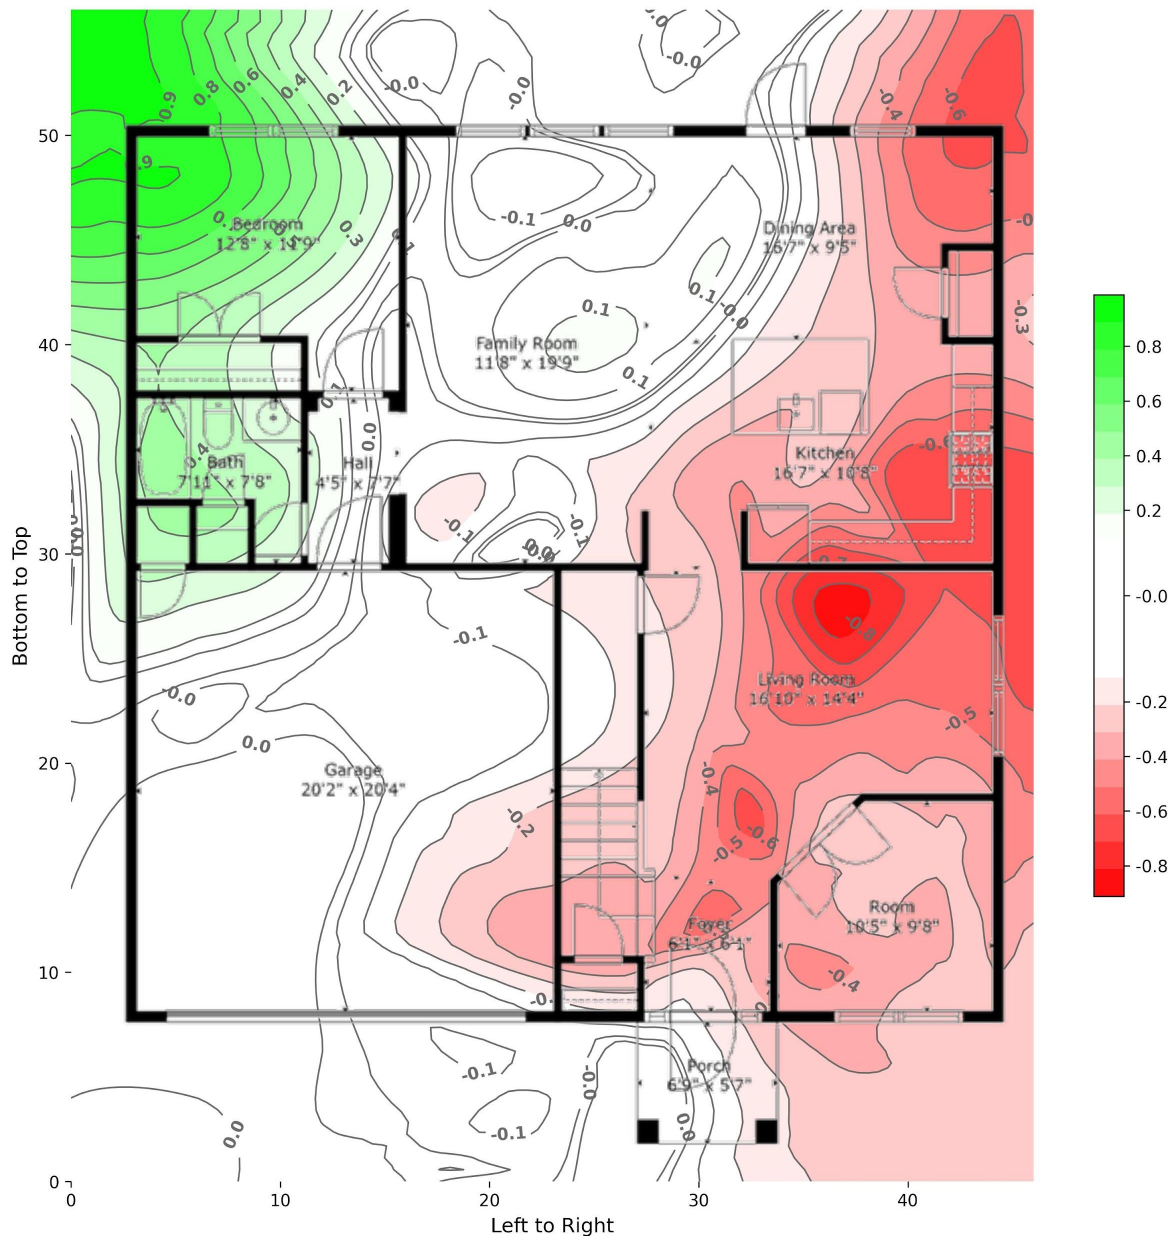
**Elevation Plot Difference Graphic (Figure F)**

A previous elevation plot completed in 2022 was available to use as a baseline of movement progression. Elevation differences are shown that show us the clear progression of movement from one date to another. As part of this evaluation, a contour mesh showing the elevation differences between the current contour mesh and the baseline was processed and is shown below.

The mesh contour graphic above in Figure F shows areas in red that are lower than the baseline elevation plot and areas of green that are higher than the baseline elevation plot (from the provided drawing completed in 2022). The darker the color (both red and green) the larger/smaller the elevation differences.
