## Engineer's Opinion

On 8/21/2026 a truss evaluation was performed at the property located at address [REDACTED] Cibolo, TX, 78108, which consists of a 1681 square-foot single family attached structure built in 2015 (11 years old) with a slab on grade foundation.

*Site Assessment for:*  
**Damaged Truss Evaluation Inspection**

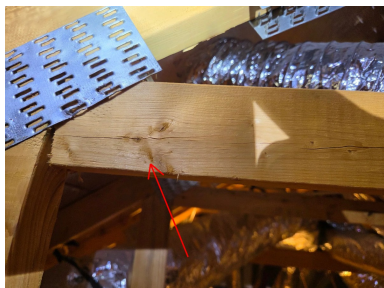
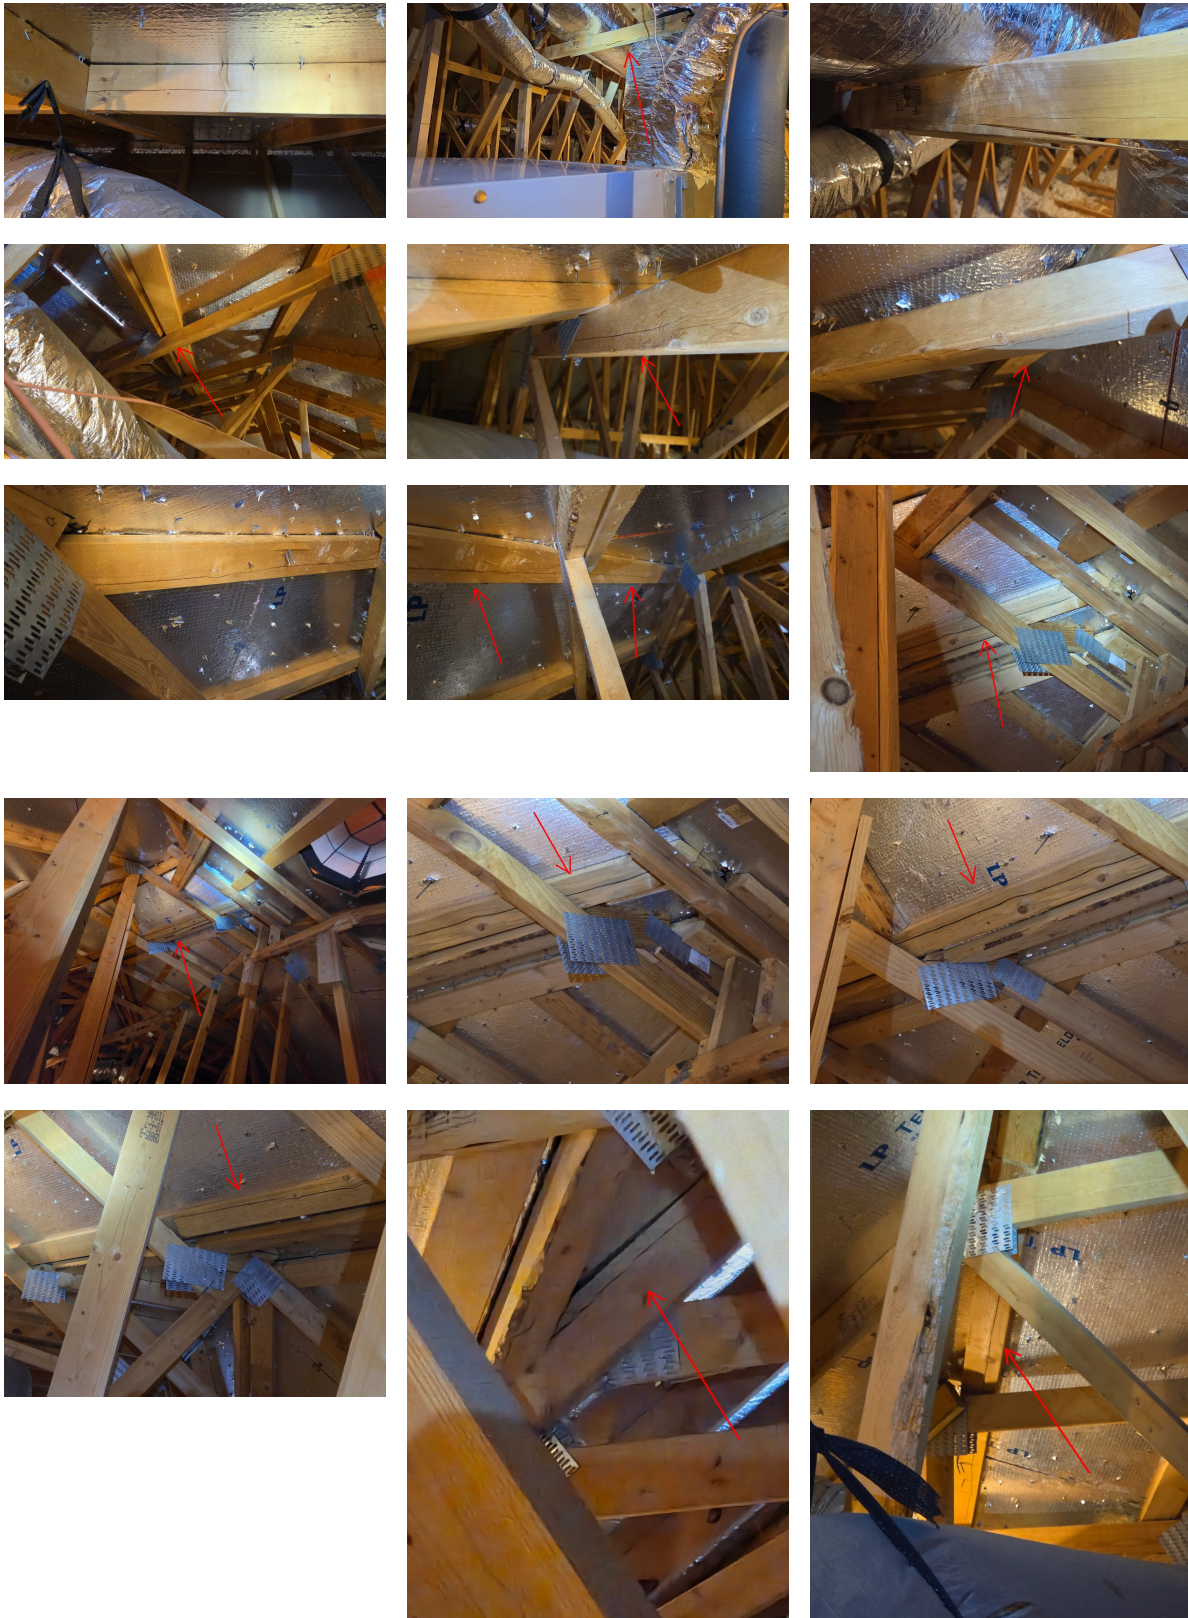
General photo(s) of the damaged member areas well-documenting general area of concern and the specific problem.

**Multiple roof truss framing members were observed to be damaged/split.**

Multiple roof truss framing members were observed with damage/splitting. The affected members were not concentrated in one specific area but were observed at various locations throughout the attic. No excessive movement or conditions that appeared immediately unsafe were observed when accessible framing members were checked using light manual pressure.
