Report V1.0

# Engineer's Foundation Evaluation

123 Main St, Your City, TX, 12345

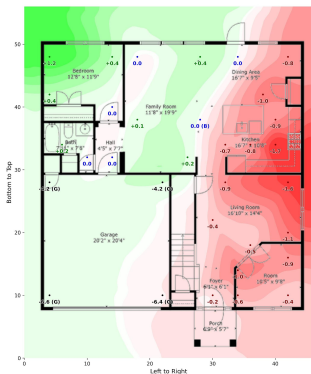
Figure A

This evaluation indicates clear signs of foundation issues. Calculations were not found to be within industry standard limits. Remedial measures are required to bring the foundation to a more level condition. It is recommended that foundation stabilization be completed as soon as possible, if possible within the next year. In addition, visual deficiencies noted should be resolved after foundation improvements have been completed. We also recommend you perform another house elevation plot after repairs have been completed to memorialize the elevation changes. Due to the nature that foundation work is recommended, it is imperative that you read the entire report in detail for a comprehensive explanation of this conclusion.

*It is highly recommended that the client find, review, and comprehend these various colored Figures A, B, C, D, F located throughout the report, as these figures are instrumental in the development of the conclusions derived.*
